**Second Quarterly Technical Progress Report on
Development and Testing of Electrolyte Matrix
Combinations for Mercury-Potassium Fuel Cell
(13 March — 12 June 1963)**

Engineering Department Report No. 3455

NASA Contract NASw-476

Allison Division

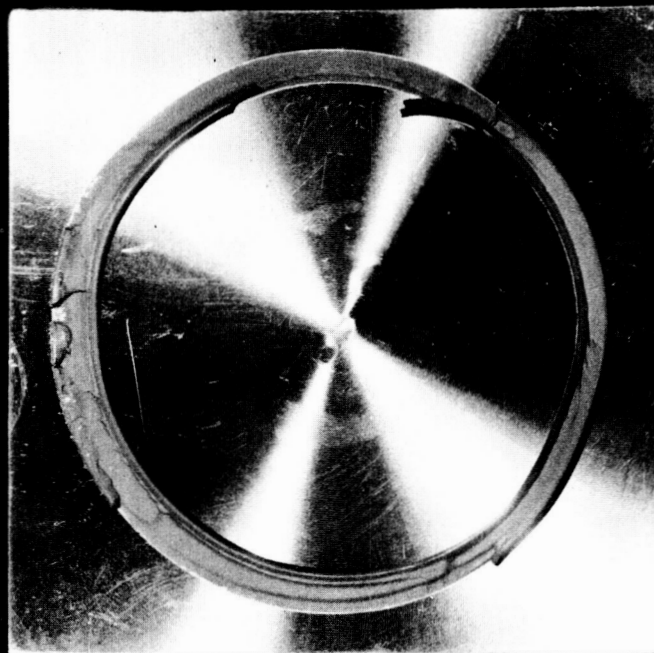
Figure 3. Silicon "O" Ring Seal Test Teardown

A special test was performed to determine that the silicone rubber could be used in the form of a small O-ring in the assembly of a composite matrix cell. A 35-hr test was performed while manipulating the flange tightening sequences in a manner simulating actual cell operation. Figure 3 shows the results of this test. To separate the plates after cool down, it was necessary to pry them open. Although the rubber was torn apart, it remained in contact with the metal at all points. This indicates extreme bonding characteristics which will ensure a good seal.

1. An excess of electrolyte will break the rubber down into a liquid.
2. Limited contact with electrolyte causes a brittle substance which remains functional as a seal.
3. Compatibility with potassium and mercury is excellent.
4. Some reaction is evident with electrolyte-saturated potassium. However, limited contact as occurs with the edge of a seal does not cause seal failure, but only forms a limited amount of brittle material.

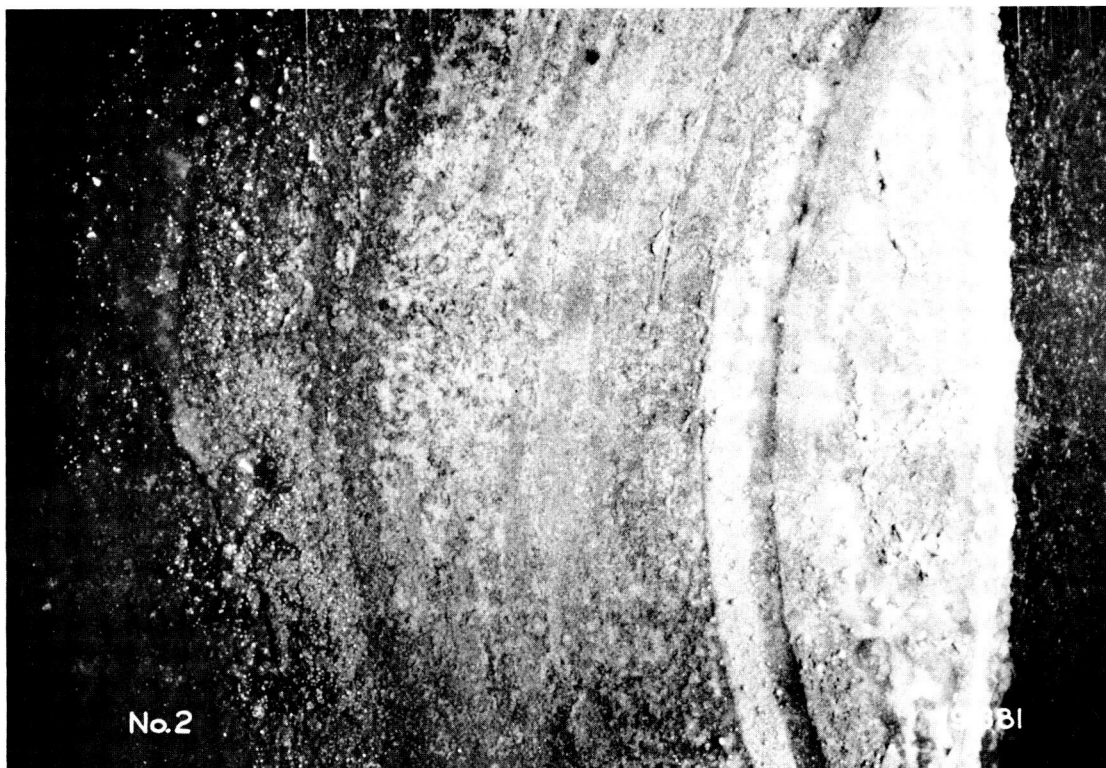
Figure 10. Sections of Matrix from Second Cell Seal Region

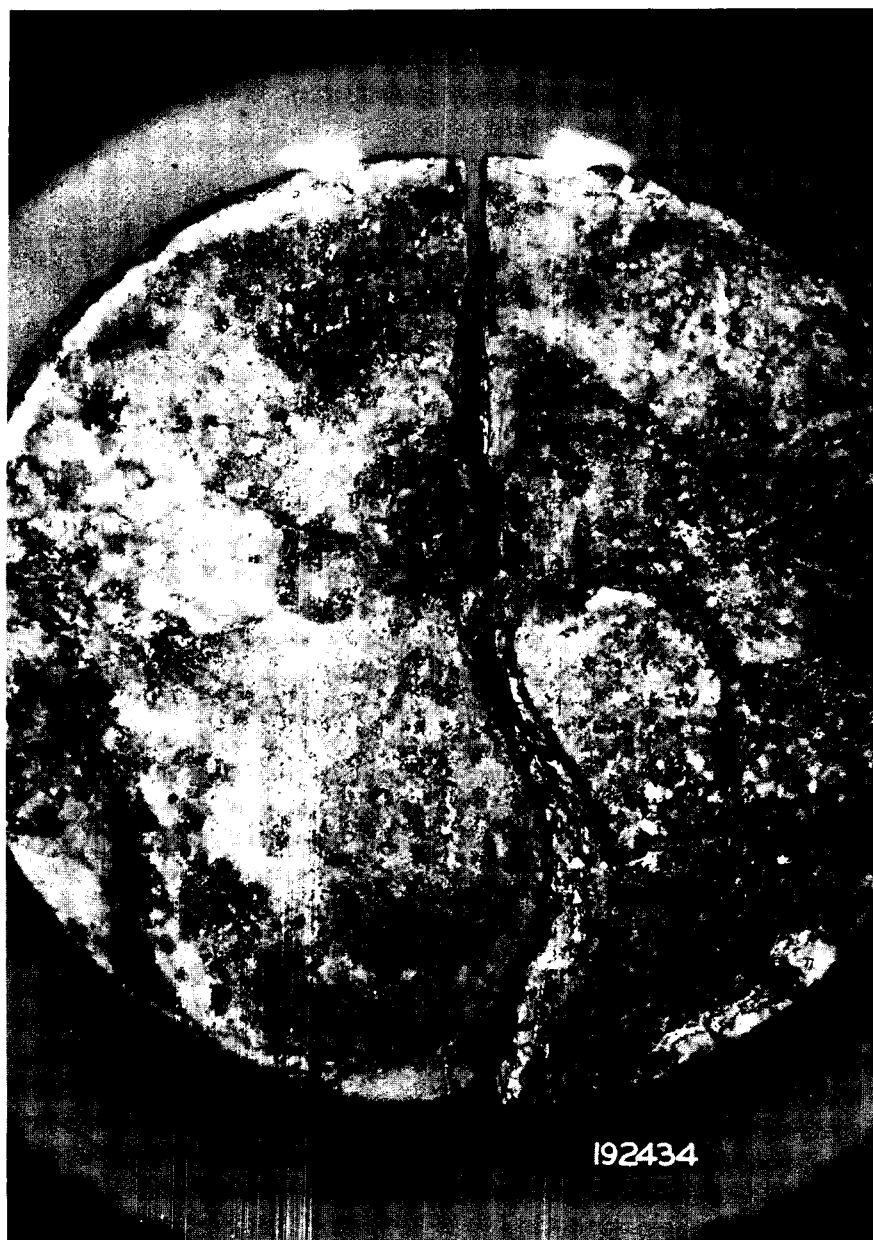
Figure 12. Electrolyte Matrix after Test Number 6—Note Cracks

of approximately 0.8-in. Some smaller grooves are also visible in Figure 12 which shows the specimen after it was deliberately broken along the large crack. Figure 13 shows the edge view. Only about 10% of the material was serving as a strong bond between the two halves. Potassium completely penetrated the cracked surface. The grey regions are deposits of K metal which arrived through the normal solubility of the LM into the salts.
